# **Brush Carriage No.163**

# **REALIZATION REFERENCE BOOKLET**

by Doug Rose

to be read in conjunction with DRAWING 1 – EXTERNAL APPEARANCE DRAWING 2 – INTERNAL APPEARANCE DRAWING 3 – ROOF and UNDER-CARRIAGE AND DRAWING 4 – DETAIL ENLARGEMENTS

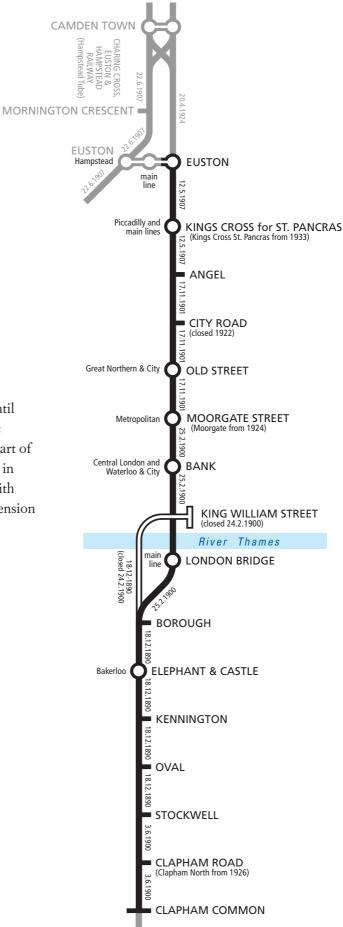
Extent of the railway from opening until takeover by the Underground Electric Railways of London Ltd, to become part of its London Electric Railways network in 1913. The diagram also shows links with other railways and the subsequent extension to Camden Town. of reversing trains was adopted, enabling a locomotive always to be at the front.

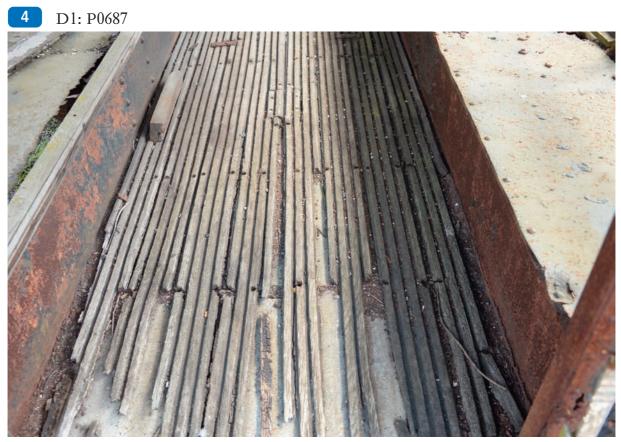
Wooden slats fitted on top of lito-silo base above a corrugated metal floor. (Lito-silo is a pseudo concrete largely composed of whiting, cork dust, iron oxide and cement.)

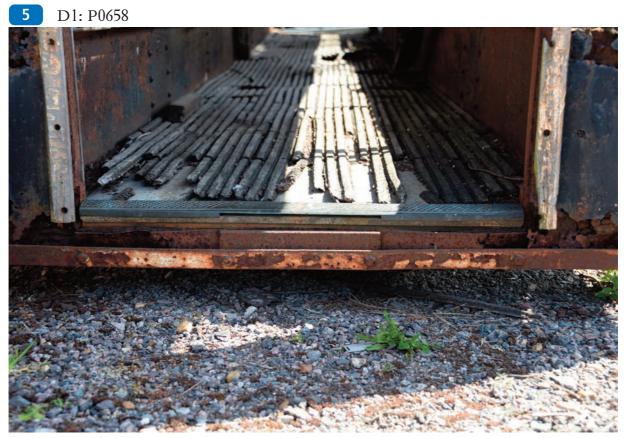
Floor slat end tread over lito-silo, also showing vertical teak moulding and lower door runner.

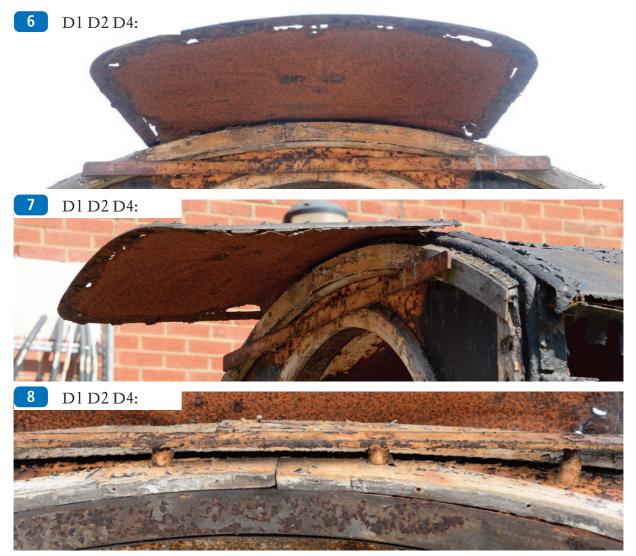
The overhead metal runner is clear of the teak mouldings and supported by six short horizontal metal posts secured from inside.

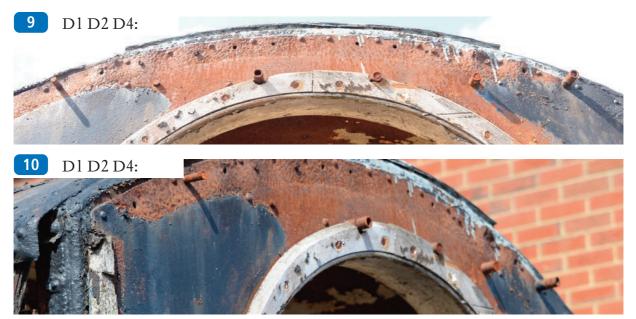
Collets were fitted around the bolts to a fix the distance for the runner clear of the mouldings.

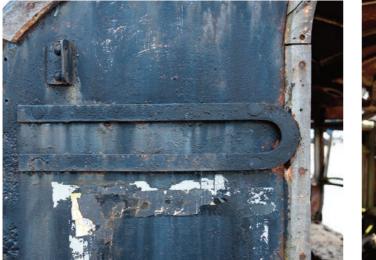
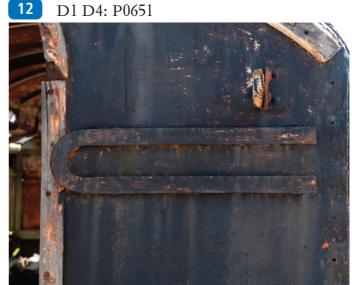
Above: the mid-height door runners as seen from the exterior, with their related door stops above them. Below: the mid-height door runners as seen from the interior, showing the reinforced metal support plates.

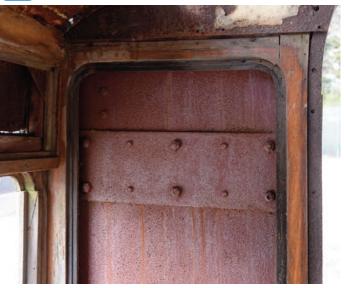
# 15 D1 D4: P085416 D1 D4:

Oblique views of a pair of mid-height door runners. These metal runners guided a grooved wheel beyond the outer vertical of the door frame. The groove of the wheel sat with one flange inside the runner and one outside. The door stop bracket can be seen above the runners.

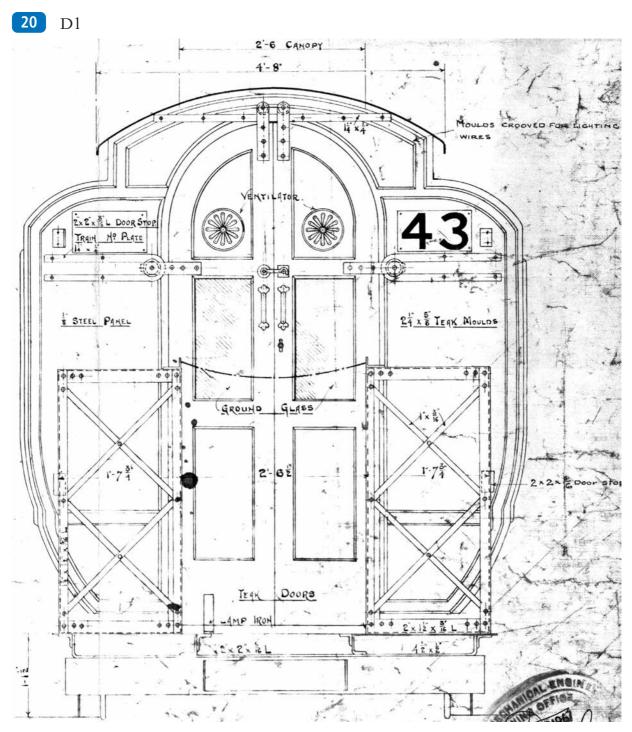
The doors had been removed by the time the carriage arrived at Neasden. The handles, hasp & staple and right-hand door lock detail have been derived from the general arrangement drawing.

The train number and set number (set '43' in the illustration above) only appeared on the end carriages, of which no.163 was not one. Note: The set number was a number given to each new semi-permanently coupled train of carriages. The number generally remained with a set throughout its life, although some changes were necessitated when sets were reformed to extend train lengths to offer extra capacity. See also Ref 105.

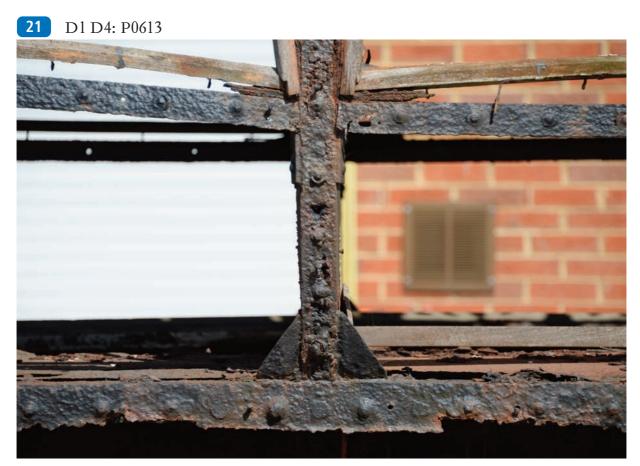
Flitched beams formed the main side structures. Below the window frames can be seen the square section upside-down 'L'-shaped 2-inch flitched beam. The lower beam, supporting the floor, was of 3-inch 'L'-shaped construction, also with its flat edge on top. The top beam (above the window and not in this photograph), was also 'L'-shaped, with its flat edge at the bottom. The verticals were a two-inch square section 'U' shape and all with teak inserts. The mid-height horizontal beam had corner brackets inside and fixed to the uprights. The lowest beam had three-dimensional brackets above it, serving the same purpose.

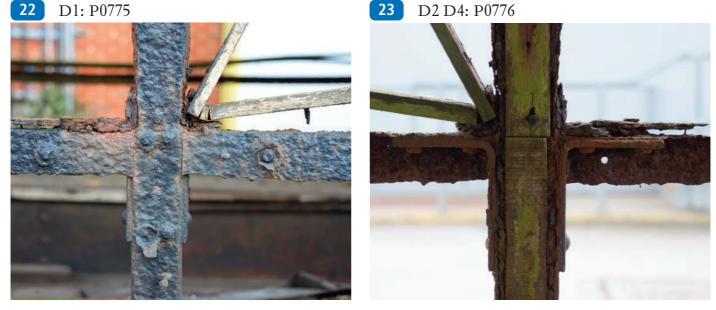
Above: The internal square brackets can be seen securing the continuous vertical to the horizontals abutting either side. Very rusted metal fillets were apparent on all four sides between the window frames and flitches. Right: The same joint from the inside.

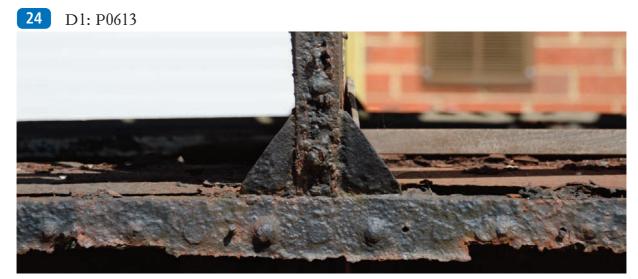
The three-dimensional brackets, one each side of the vertical, above, seen from exterior and below, as seen from interior.

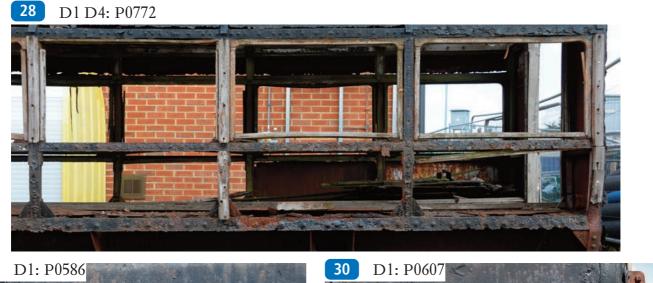
There was evidence of metal fillets between the flitched beams and all four outer edges of the window frames, though their purpose remains undiscovered. When mouldings were in place these were not visible.

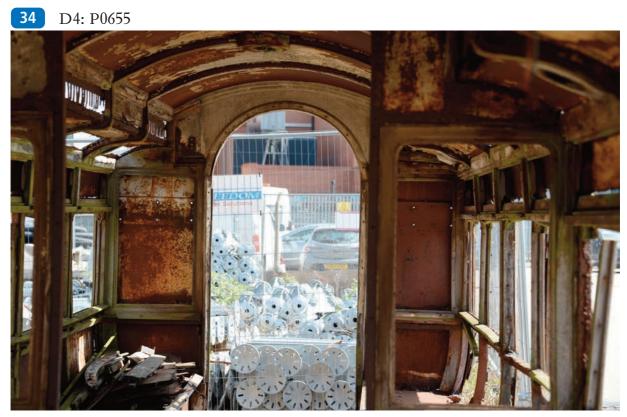
Panelwork inside both doorways was largely in place and made inspecting the structural wood and metalwork behind them impractical.

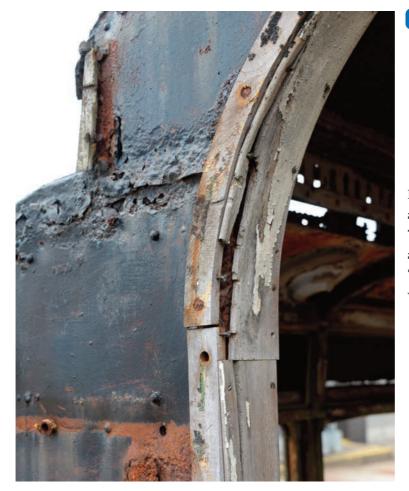
**35** D4: P0833

Detail of teak moulding outside and on inner doorway surround. The inner doorway frame and arch above were square section 'L' shaped mouldings of 1<sup>3</sup>/4-inch width (seen from inner edge).

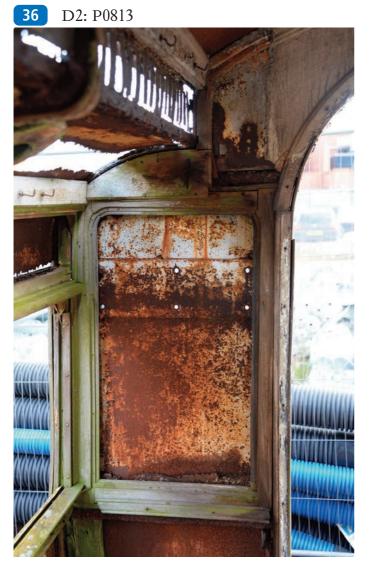
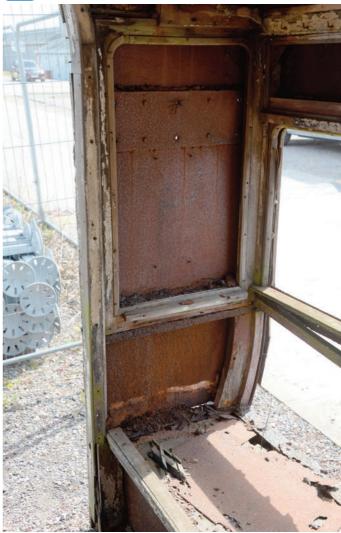
**38** D2: P0796

Above and right: Joinery at upper corners, showing the interior of a window, the window ledge, and mirror frame fitted either side of the doorways.

> Below mirror frame level, showing metal cross member connecting the doorway upright and vertical 'L' shaped flitched beam; the joinery of the seat frame ends and leading edge are also shown.

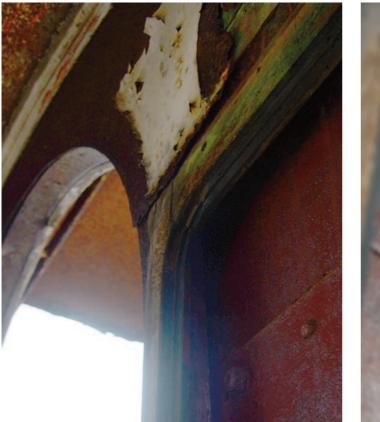
The four interior corners of a doorway end mirror frame, showing the inside of the exterior metal panelling, and reinforced plate with its bolts for the exterior door runner. The external teak flitched framework created a void between the inside of the metal panelling and the rear of the mirror glass.

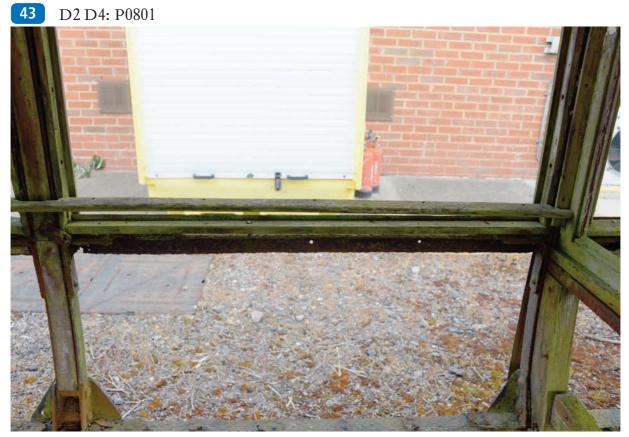
Detail of joinery showing internal window frame and window ledge at junction with the carriage's central draught screen.

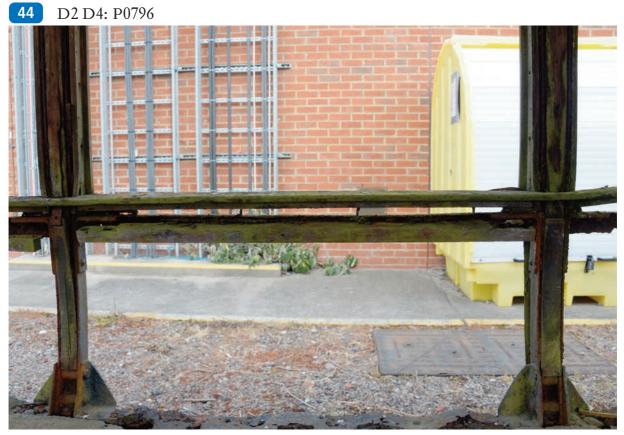
Detail of joinery showing an internal window frame and window ledge midway along.

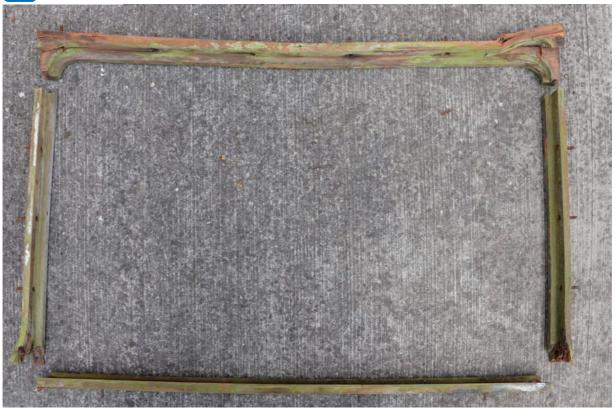
Interior of a removed window frame. All four sides of the wooden frame were rebated to receive the 1/4-inch plate glass, with an internal wooden bead securing it all round. Strips of leather were in place, either side of the glass, within the resulting groove formed by the outer frame and the inner beading.

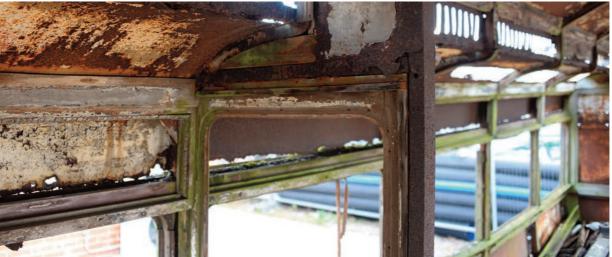
Detail of joinery at junction of advert frame above the window with the central draught screen. A void existed between the substantial wooden upper horizontal above the advert frame and the outer metal curve of the roof.

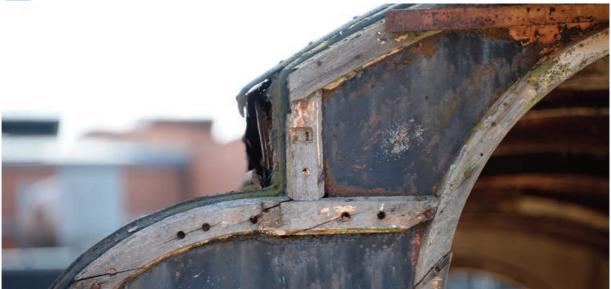
Bevel-edged moulding to doorway and ends of the carriage.

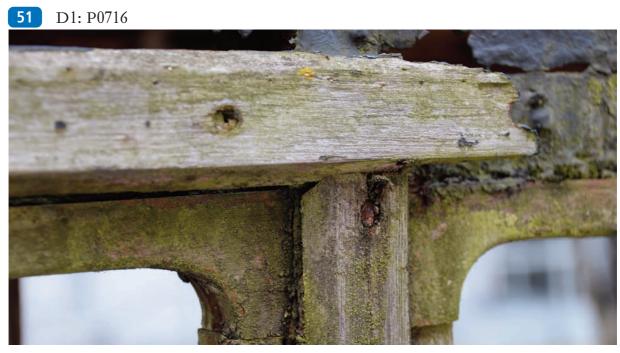
Bevel-edged teak moulding at junction of horizontal and vertical flitched beams at window tops.

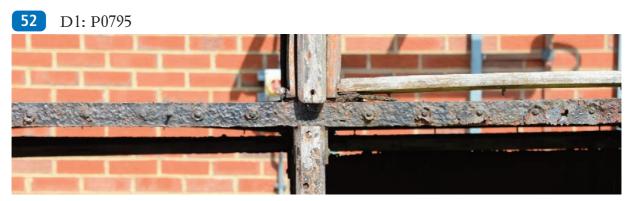
Vertical teak moulding showing mitres with (missing) horizontal.

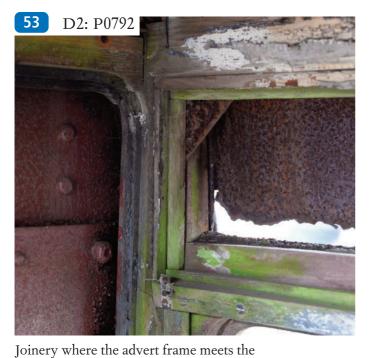
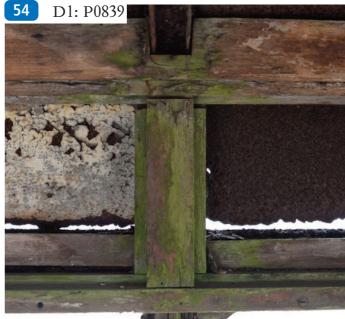
Joinery where two advert frames meet. The contoured structural flitched beam supporting across the clerestory roof above may also be seen emerging from the horizontal upper wooden framework.

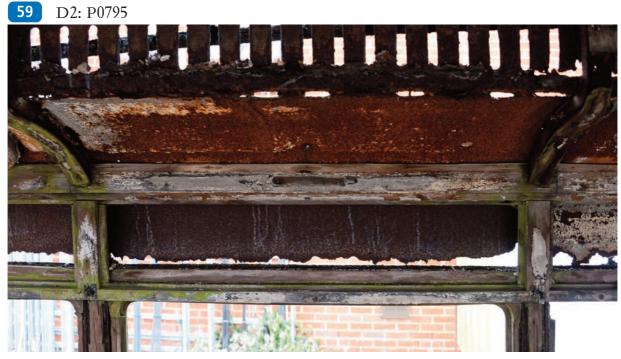
### 60 D2: P0808

A complete advert frame, also showing the inside of the external roof panelling, severely rusted along its bottom edge. The top of the upside-down 'L'-shaped beam may be seen outside.

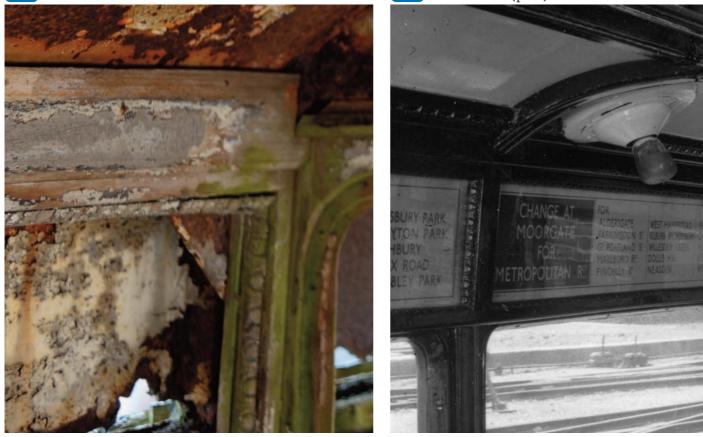
61 D2: U821 (part)

What held the front glass of the advert frames in place has not been established. Looking at one to the left (where it meets a central draught screen) there appears to be a closely spaced row of round studs around the edges, though these were not apparent elsewhere. See also Ref 110.

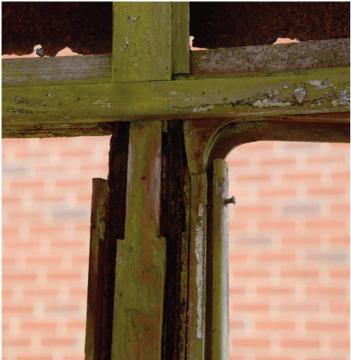
Interior where the overhead 13/4-inch beam projects below the upside-down horizontal 'L'-shaped beam and sits inside the 2-inch flitched vertical beam. The vertical teak insert may be seen rebated to receive the roof beam. 63 D2: P0934

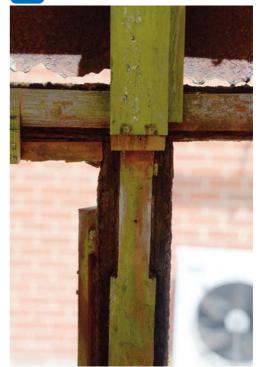
The same view but with the window frame and interior moulding removed.

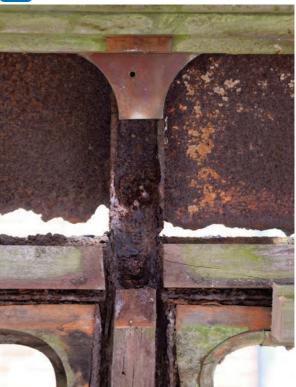
With the vertical joinery removed the arrangement of the horizontal and vertical teak inserts are revealed; the shaped rear metal plate may also be seen.

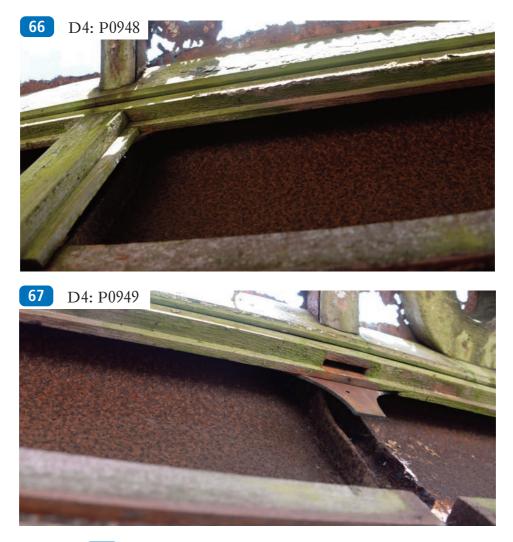
68 D4: P0929

A void is created where the lower curve of the roof panelling passes the advert panels to meet the top of the window frame beam; the advert panels lean in as a result. The tenon referred to in Ref 55 is clearly visible as it is here.

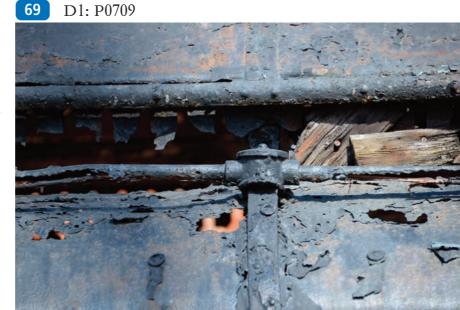
Electrical power was fed from the locomotive through a series of conduit tubes along the roof, connecting with other vertical and horizontal pipes at each carriage end. Midway along each half of the carriage a lamp was fitted inside at the zenith and the junction box seen here coincided with the structural roof strap. The conduit along the west side fed its four seating lamps and also the two at the highest point of the ceiling. On the east side the conduit only fed its four seating lamps.

The small round object by the guard's right shoulder is a dummy electrical socket. Electrical wiring was carried along the carriages in metal conduit tubing broken by intermediate junction boxes on the roof (Refs 69 and 70) to feed the lights. The cable emerged from this tube beneath the canopy at each end of the carriages before terminating in a plug. This allowed a continuous electrical line to be provided from the locomotive through the full length of

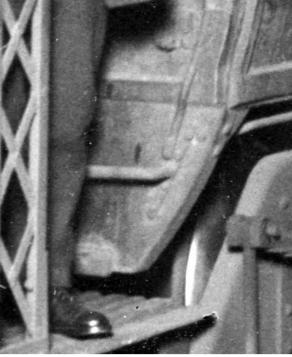
A further horizontal air pipe ran along the underside of the main bodywork. It may be seen here above the bogies.

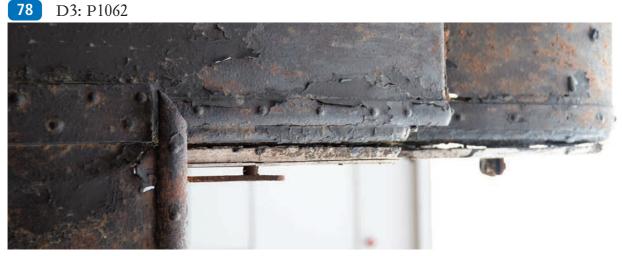
Seen from above, at the left is the edge of the canopy with the upper curved roof in the middle and the lower curved roof to the right. The teak mouldings above the doorway and metal upper door runner may also be seen.

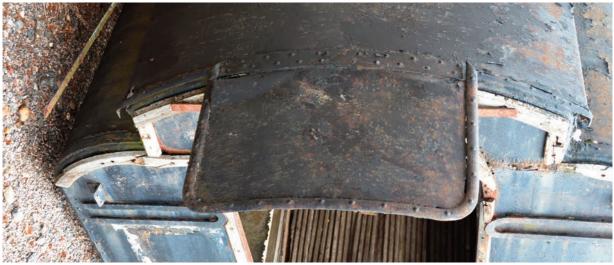
End roof strap, canopy fixings, various teak mouldings, upper and mid-level door runners (with the carriage lying on its side).

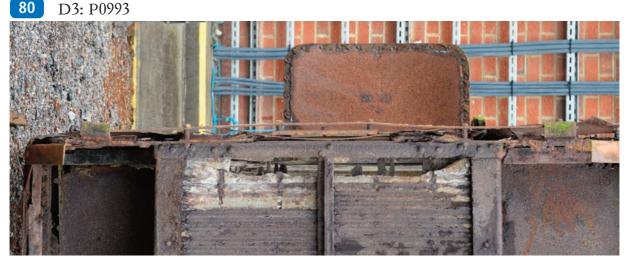
The underside of the canopy seen from below (with the carriage lying on its side).

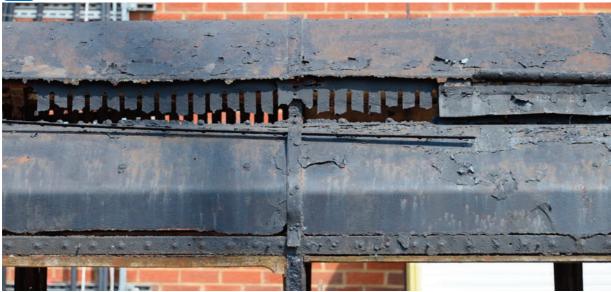
Contoured flitched roof beams followed the shape of the clerestory roof. Panel join straps spanned the roof to reach the vertical drop for the ventilation panels where they were met by a horizontal metal bead; this can be seen here broken at one of its own joins — to the right it is in place but the left-hand section has dropped onto the lower part of the curved roof. From that point a further set of straps descended to just below the upside-down 'L'-shaped 2-inch flitched beam above the windows, where they tucked under the horizontal teak moulding.

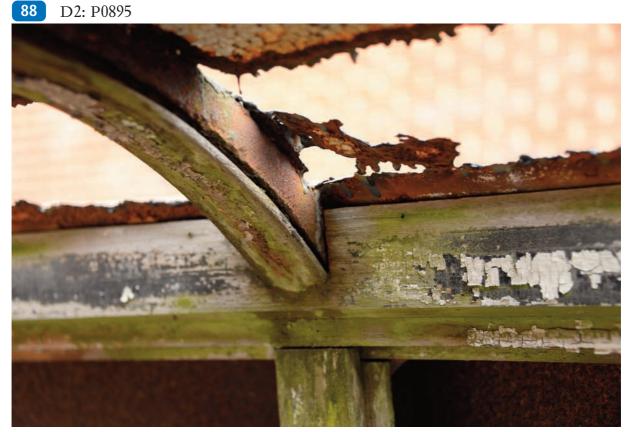
Uncertainty surrounds if the contoured roof beams had teak inserts, though external capping may be seen to finish it off.

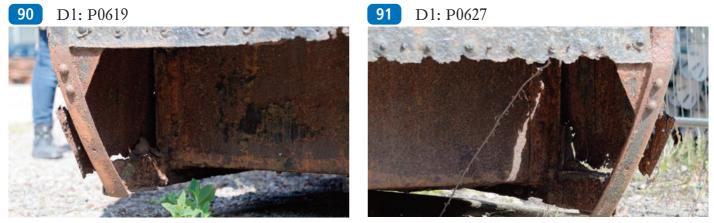
The 2-inch 'L'-shaped flitched verticals only had teak inserts above seat base level. These two photographs show threedimensional internal brackets connecting the curved 'L'-shaped vertical corner beams to the 3-inch upside-down lower horizontal beam.

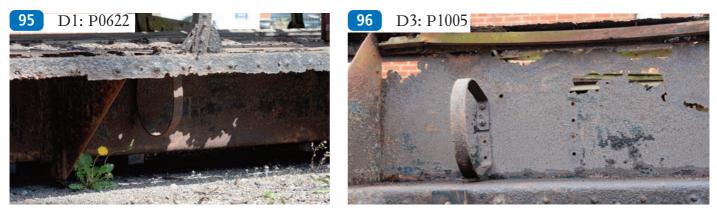
The looped strap in these images is probably one of two that held the auxiliary air reservoir tank in place. The righthand view from underneath shows a further set of four fixing holes to the right.

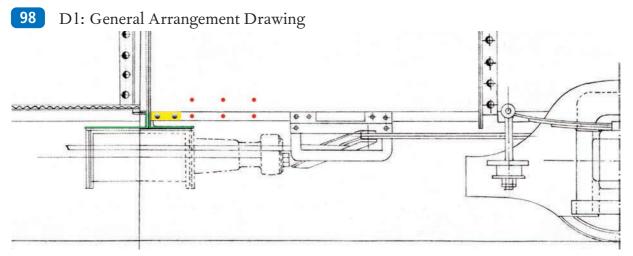
Extract from the general arrangement drawing with red dots indicating the location of the large bolts (top three dots) on the chassis side, and bottom three, which were fitted to the cross-member under the chassis — Ref 104. The drawing has been flipped to show it as almost certainly fitted to west side on the second batch of Brush carriages, though in reality most of the tank was underneath the seat base and not on one side. The two loop straps to the left (only one surviving on 163) supported the auxiliary brake cylinder, not included on the GA drawing and to the left of the above example. The yellow indicates a bracket fixing (see Ref 104).

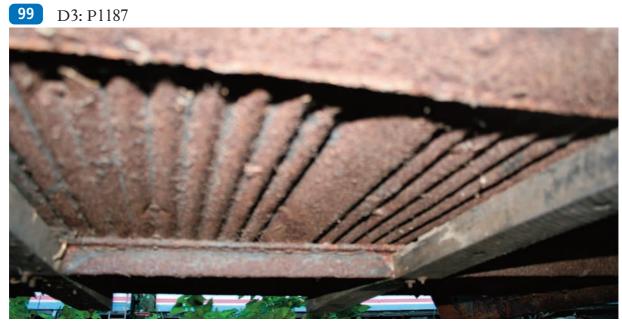
Taken when the carriage was at the Electric Railway Museum, this image shows the corrugated underfloor when it was is slightly better condition than in 2021. Source: Printz Holman.

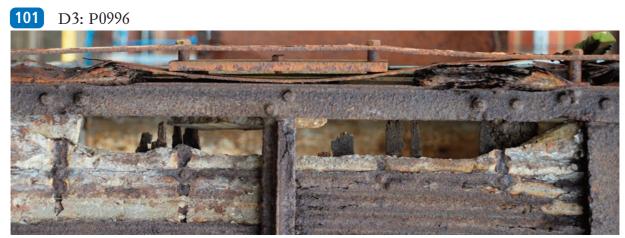
The north end of the underside. The rusted corrugated steel floor has exposed the lito-silo.

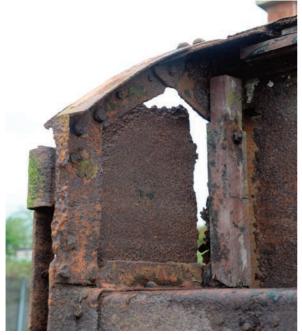
103 D3: P1034

The carriage is on its side and the under-seat plate therefore to the right vertically here. At the top of the picture a three-dimensional bracket is holding the north side panel (to the right of its doorway seen from outside) to the 'L'-shaped corner vertical and lower 'L'-shaped horizontal flitched beam. The two horizontal teak inserts have been rebated to clear the bracket.

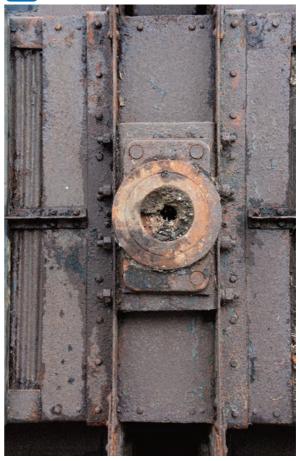
104 D3: P1037

See Ref 93. The right-angle brackets bolted to the triangular plates continue all along the underside of the chassis to support the bogie roller on the other side. This photograph also shows the bogie pivots midway along the underside.

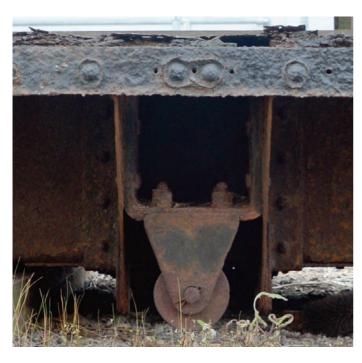
# **92** D1: P0786

> One of the bogie rollers, seen square on. A vertical 'L'-shaped bracket is bolted to connect the vertical triangular plates either side of the roller to the seating under-tray and the upright of the main chassis. [see also page 41]

The requirement to make carriages as large as possible for the comfort of passengers, while also designing them to run through tubular tunnels as small as 10' 2" in diameter, introduced tighter tolerances than would be expected on surface railways. To restrict the carriages from swaying excessively, there was no springing between the bogies and the carriage bodies. The sole means of suspension was provided by leaf springs on the axle ends.

Carriage 163 was fitted with the stabilising roller mechanism and this was also shown on the pre-production GA drawing of the Brush carriages; however, it is missing from the photograph above.

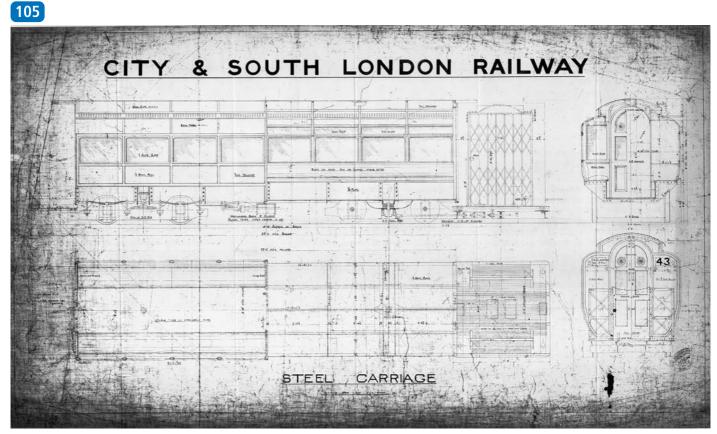
Contemporary tracing of a general arrangement drawing from 1905. The original was at a scale of 1:12. It is shown here for reference only and necessarily reduced to fit this page size.

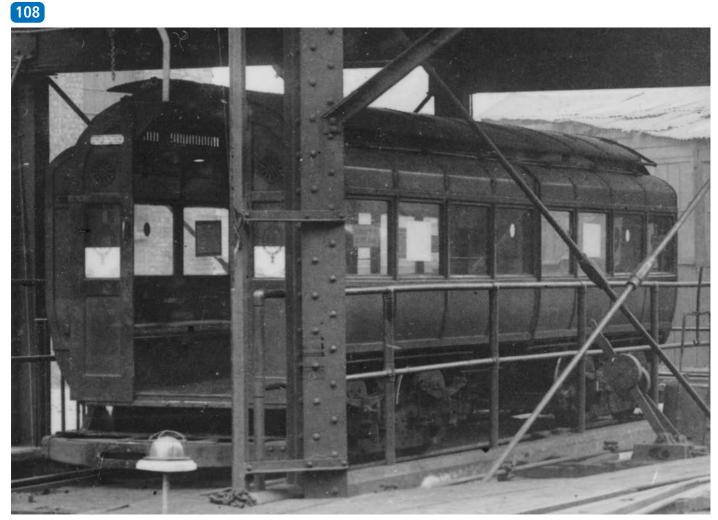
Brush carriage in the lift at Stockwell depot. Rail level was only accessibly from the depot by a steep incline initially; this lift was operational from 1907.

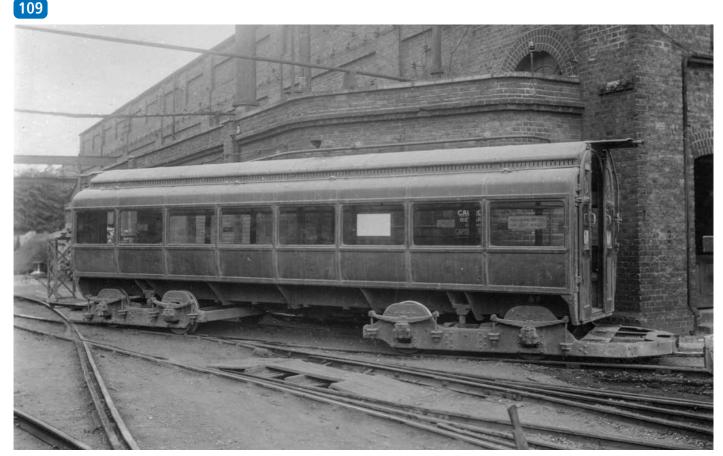
Brush carriage at Stockwell depot, probably from the first batch, showing bogies. *Source: London Transport photograph number 24709 from about 1921/22.*

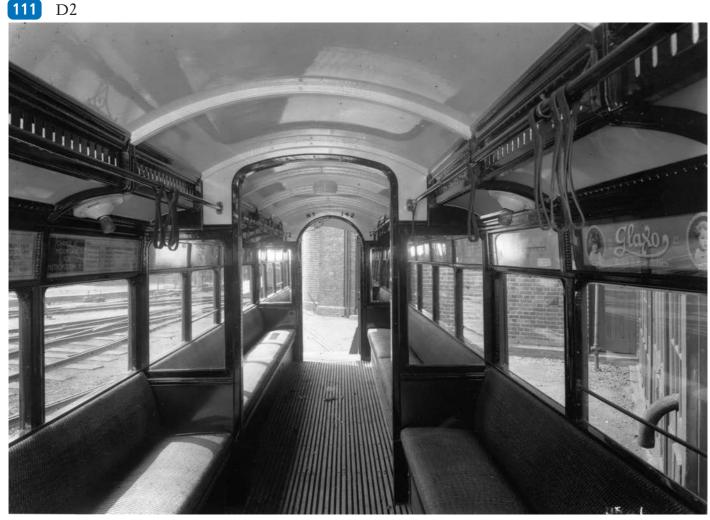
Interior of carriage no.142, from the first batch from Brush. The window bar in the right foreground window, and that on the other side beyond the draught screen, might have been used to place a 'Not Stopping at...' board, though this uncertain. This photograph was taken about fifteen years after introduction. Possibly of important note are the glass domes missing from the light fittings, the wooden slats on the floor not visible in Ref 110, and the now white overhead beams and doorway panel surrounds.

Things are not so simple when it comes to the hand straps. While photo U821 (Ref 110) is not of 163, or from the second batch of Brush carriages, we can see that at least one strap is missing on a carriage that appears to have been prepared for the photographer. Closer inspection suggests that one of the straps is a replacement (or maybe that is an original and the others are replacements?). Also of note are the retaining brackets for the wooden bar from which the straps hung. These are significantly different in outline and mounting height on the photo when compared to the GA drawing. If, as is likely, items such as door handles and mounting brackets were manufacturers' standard stock fixtures, it is reasonable to assume that the brackets depicted in the photo may have been used on the second batch of carriages.

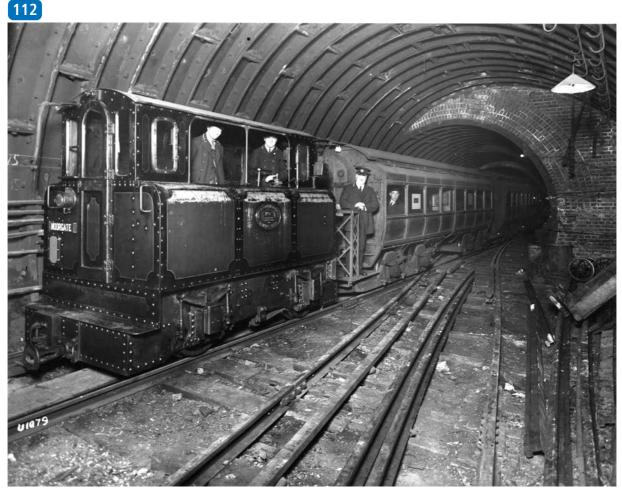
the train. The connections between the carriages were made by inserting a plug from each carriage into a double ended socket on the roof above the intermediate gated platforms between the carriages. The plug on the cable on the front carriage was plugged into a live socket high on the end of the locomotive just to the side of the door. The cable that emerged beneath the canopy of the rear carriage carried 500v, but there was no carriage or locomotive to which it could be connected. It was therefore plugged into a dummy socket; presumably to stop it swinging around and getting damaged. These dummy sockets were only fitted to the end carriages and the one in this photograph is not in use as the electric cable has been connected to the locomotive to provide the feed to the train. Carriage no.163 was not an end carriage and so did not have this socket at either end.

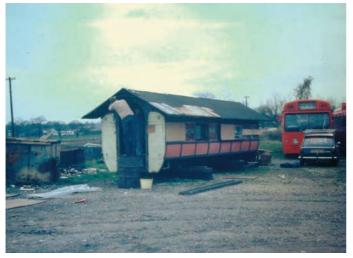
PICT0134 116

Members of the London Underground Railway Society at Ruislip depot removing the pitched roof and starting the (never completed) restoration. Source: Steve Smith

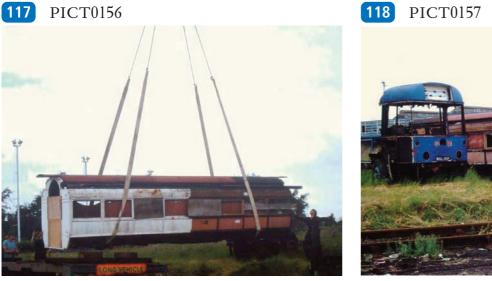
PICT0156 117

The carriage being lifted by crane to a new location at Ruislip depot, next to no.135. Source: Steve Smith

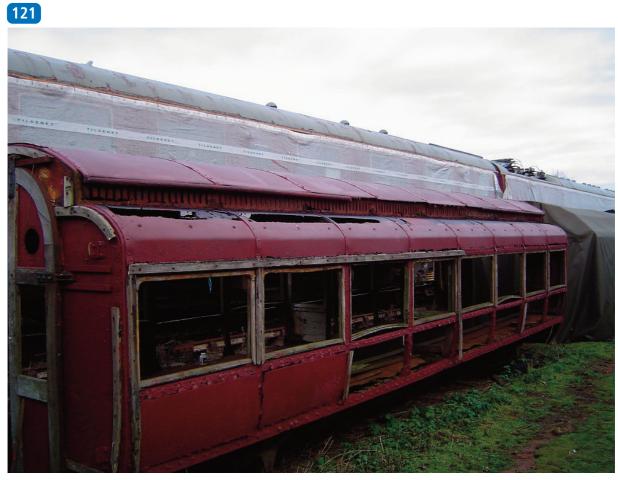
Evidence of re-paint primer preparation at the Electric Railway Museum. Image from https://redoxidepaintlsmm.wordpress.com

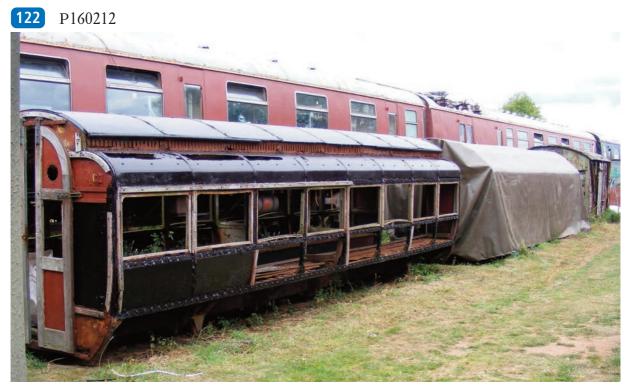
Further evidence of re-paint at the Electric Railway Museum. *Source: Flickr posting dated 16th February 2012*
